## Soft Market

**Summary:** From impact attenuation to accessibility, playground operators face a number of hard choices when specifying safety surfacing.

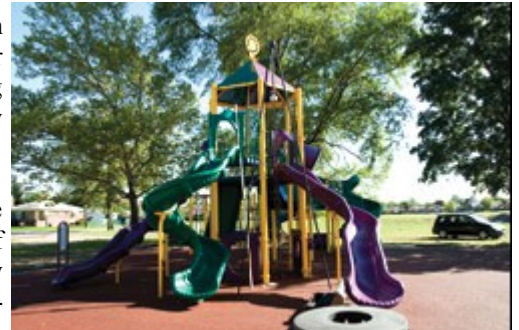
**ASTM F1292 Test Report** Date: September 17, 2008

Date of test	17/09/08	Prepared in place surface	Name of test operator	Triax2000	
Product name	EverPlay	Date installed	Sept. 2008	Critical height	1.21m
Thickness of surface material	1.00m	Minimum	1.00m	average	1.00m
Surface composition	rubber granules and aggregates	Surface condition	1 New	Surface temperature	1 New
Number of tests	1 Clear and water	1 Green	1 No	1 Yes	1 No
Surface condition	1 New	Surface temperature taken 1" depth for loose fill or 1" depth for unitary	1 New	1 New	1 New
Other test conditions		Other test conditions		Other test conditions	
Wet, wet/dry or range	number	condition	equipment impact test	surface	
Wet	1	Wet	1	1	
Wet/dry	1	Wet/dry	1	1	
Wet/dry	1	Wet/dry	1	1

The drop height each test location shall be the greater of the critical height for the surface material, the fall height for the play structure or stand or the relevant playground standard or the height specified by the contract operator prior to purchase. The drop height is physically measured. The drops are performed from the same drop height at the same point on the surface.

Drop #	Drop	Drop location in relation to structure	Platform	Velocity	Green	HIC
1	1.21m	Top of barrier next to green central slide	DIS 0045	26.1	64	386
2	1.21m	Top of barrier between green slide and climbing wall	DIS 0041	26.1	64	386
3	1.21m	Top of barrier between green slide and climbing wall	DIS 0041	26.1	64	386
4	1.21m	Top of barrier between green slide and climbing wall	DIS 0041	26.1	64	386
5	1.21m	Top of barrier between green slide and climbing wall	DIS 0041	26.1	64	386
6	1.21m	Top of barrier between green slide and climbing wall	DIS 0041	26.1	64	386
7	1.21m	Top of barrier between green slide and climbing wall	DIS 0041	26.1	64	386
8	1.21m	Top of barrier between green slide and climbing wall	DIS 0041	26.1	64	386
9	1.21m	Top of barrier between green slide and climbing wall	DIS 0041	26.1	64	386
10	1.21m	Top of barrier between green slide and climbing wall	DIS 0041	26.1	64	386
11	1.21m	Top of barrier between green slide and climbing wall	DIS 0041	26.1	64	386

**FALL EXAM**  
The Triax2000 is the only instrument capable of determining on site whether a surface is in compliance with ASTM International's impact attenuation standards.

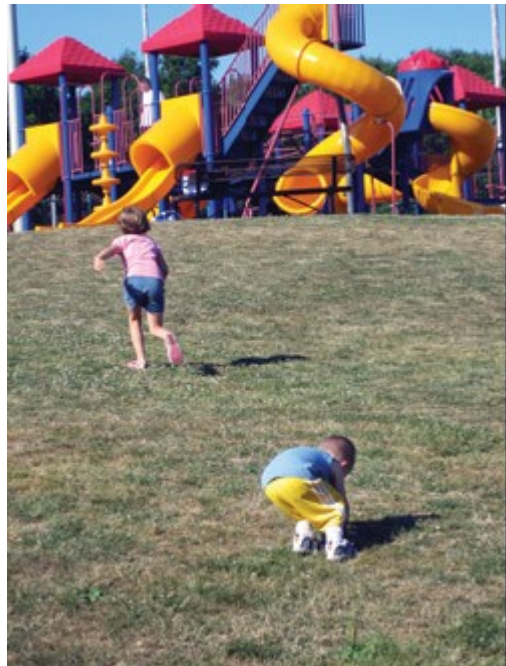
An estimated 85 to 90 percent of all playgrounds employ some form of wood surfacing, requiring regular redistribution and replacement of material.

Each surface has its selling points. Synthetic products are virtually maintenance-free, save for instances of vandalism, but are the most expensive at roughly \$8 to \$10 per square foot. They can also prove susceptible to natural degradation due to temperature fluctuations, standing water, ultraviolet rays and the migration of silt, not to mention heavy foot traffic. Conversely, loose-laid products require regular maintenance to redistribute material that has been kicked out from underneath swings and other potential fall areas. Engineered wood fiber, shredded in such a way as to cover playgrounds with a deep but relatively stable thatch layer, costs as little as \$1.50 per square foot initially but must be supplemented with new material annually (or at least every other year) to maintain proper depth.

Moreover, the impact-attenuation properties of wood, which is used in an estimated 85 to 90 percent of all playgrounds, can also be compromised as the seasons change. "The problem is the cusp of spring, when surfaces may not yet be working perfectly," Huber says, pointing to cold-weather climes where children are eager to seek relief from cabin fever. "The city of Calgary has banned wood chips, the reason being that they get what are called Chinooks — warm winds that come over the mountains — and they'll have 75-degree weather for two days. Most owners do not understand that wood systems are insulating. A lot of them walk across the playground and say, 'Look, the wood chips are loose.' Sure, the top inch-and-a-half is loose, but the bottom 12 inches is a solid block of ice."
